LV electric strike – Abbotswood Rd HP27

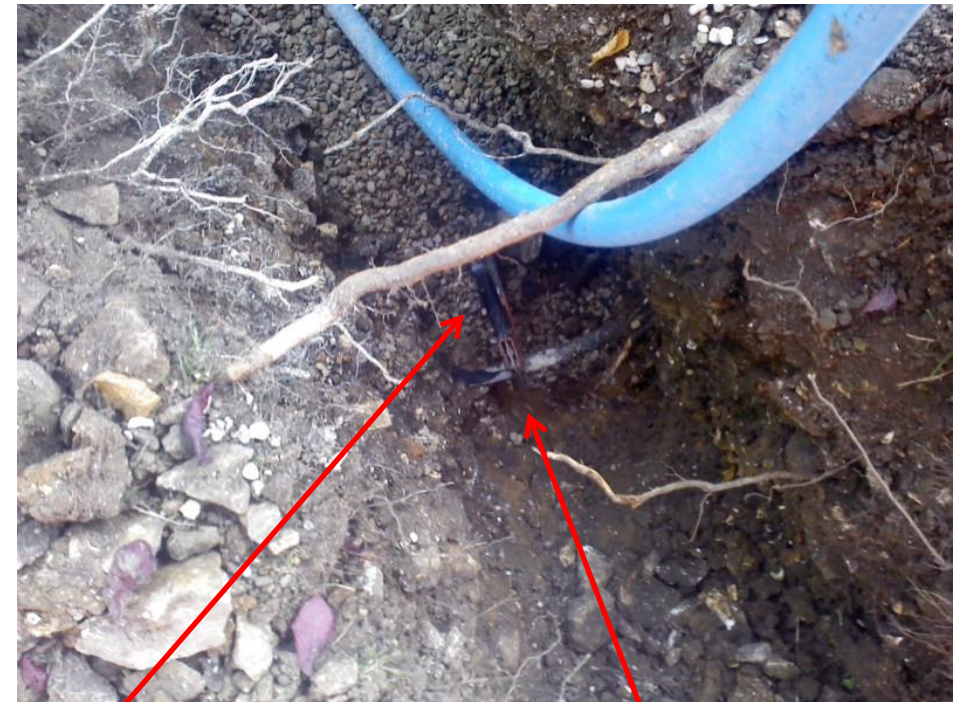
- * On the 12th October 2015 a KCD R&M team were continuing an ongoing job to replace a section of leaking water service. They had CAT'd the area and found one known LV electric cable on utility plans.
- * During the excavation the team identified a black service they assumed to be P.E water. The team leader cut the service with a pair of polycutters.
- * There was a loud bang, a flash and a puff of smoke – at which point the team realised they had cut an electric cable,
- * With incredible fortune there was no injury (in part due to use of insulated hand tool), just some slight singeing of hair to the team leaders hands.

- Team had assumed the 1/2" black poly service was water.
- No actions were taken to confirm the exact nature of the service prior to it being cut.
- CAT was only used prior to the excavation and not during.
- There was no last check on the service to be cut with CAT.
- CAT only used on two modes and genny not used at all
- No gloves were being worn.

Polycutters

LV cable

- ALWAYS VERIFY THE NATURE OF SERVICE TO BE CUT – PLEASE NEVER ASSUME. YOU MIGHT NOT BE SO LUCKY.
- Use CAT and genny during excavations
- Record on the risk assessment what measures have been taken to verify nature of service prior to any cut / linestop etc.
