HV Cable strike Ludgate Hill.

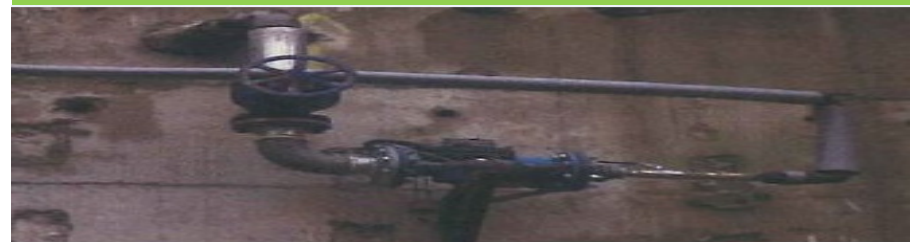
On the 11th October 2015 a team were excavating to locate and cap a redundant fire main, The work was in two sections. Firstly to dig down to find the original footpath at a depth of 2metres. This went without incident, On the second section of the dig, the area was re scanned and digging started through 200mm of reinforced concrete. At 200mm the outer casing of a HV cable was caught, this tripped and no flash or injury occurred.

- As gang were digging down through the concrete footpath, the bucket of the JCB digger came in contact with a HV cable.
- Drawings did not indicated the HV cables (bank of three) in the footpath. No crossing services or supplies were shown crossing the dig area No scaring apparent.
- No visual signs of electrical junctions in a reasonable area of dig site.
- The team had uncovered all services noted on the drawings provided.
- Several services not shown on all drawings had been located and successfully exposed without incident

- Ensure drawings provided to gangs are most up to date available and in colour.
- Always use a Cat and Genny to survey entire site before work commences.
- All gangs to wear task appropriate PPE as stated in the method statement and risk assessments.
- Ensure all operatives are trained and competent for the task they are undertaking.
- Nothing we do is so important we cant make time for safety
- More consultation between all concerned at the planning and design stage. The need for this excavation could well of been eliminated at this stage.
