## LV electric strike – 33 Coley Hill, Reading, Berks, RG1 6AE

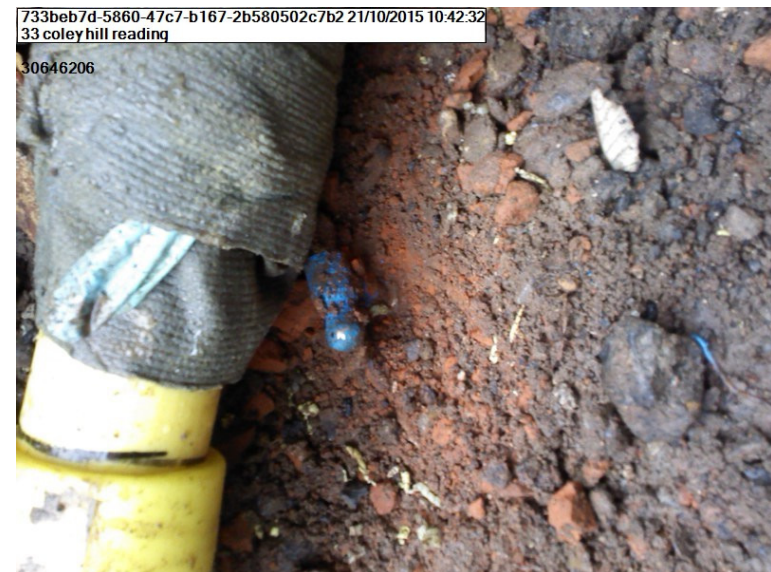
\* On the 22nd October 2015 a KCD R&M team were undertaking the replacement of an existing stop tap for a new atlas unit. They had CAT'd the area in and around an already open excavation (Dug by national Grid ,GAS).

\* The team identified what they thought to be a water service as it appeared to be made of a lead material. The team leader then cut the service with a pair of hand held pipe cutters

\* At this point there was a flash and a realisation by the team that they cut what is now known to be a lead encased electrical cable

- Team thought that as material seen was lead then it was the water service
- Assumptions made with out further checking
- CAT was but not sufficiently to denote existence that service was in fact electrical
- There was no internal check at property although access was granted
- CAT was only used in power mode and genny was not used

- NEVER make an assumption that metal exteriors denote water service
- Use both CAT and GENNY (THEY CAN PROTECT YOU) when used correctly
- Share the findings and experience through communication at all levels to hopefully prevent a re-occurrence
