High Potential Incident Alert - 191

November 2015

Redundant pipework falls to deck

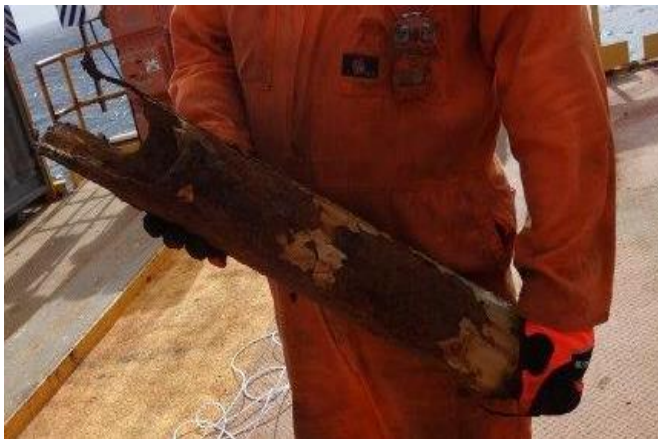
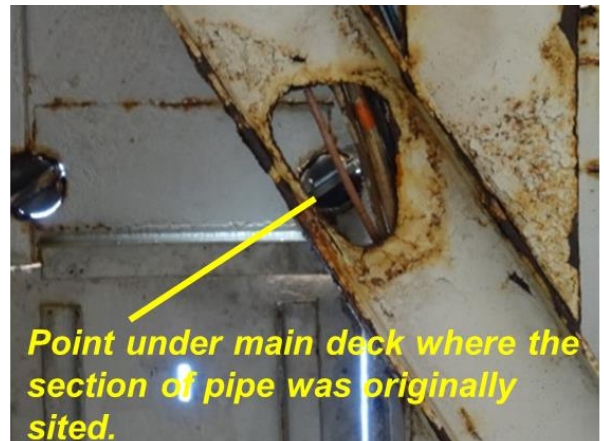
The platform operator discovered a one-metre section of corroded redundant 4-inch pipework weighing about 15kg lying on the deck.

During a storm, a section of pipe broke free from its welded mounting point and fell about 8 metres to the cellar deck.

- Corrosion of the redundant pipe.
- Redundant pipe was not removed when it was no longer needed.
- Poor design – the pipework was not painted on the inside and caps on the main deck were not sealed.
- The pipe's location posed a hazard – it was directly over a walkway.

- All pipework – including redundant pipework – should be monitored for corrosion.
- Once it is no longer required, structural pipework should be removed as soon possible.
- Ensure structural changes meet the required standards.
- Consider the safety of personnel when selecting where to place any structural changes.
