Health and Safety near miss Power Road Bridge

Date and time of incident:	27/07/16 08:30	Injury severity:	n/a
Location of incident:	Power Road Bridge	Level of investigation completed:	Initial
Operating unit:	Utilities	Potential severity:	Serious
IN reference:	Input IN reference	Operational disturbance:	Other cause
Alert completed by:	Tony Liberty		
People involved:	Tony Iveson

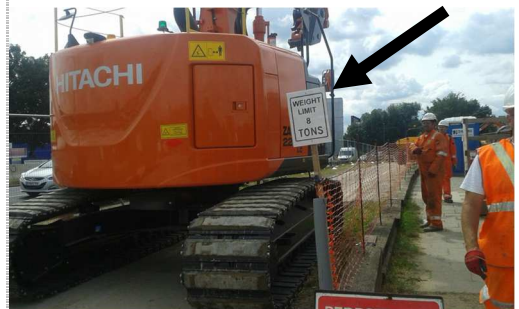
On Tuesday 26th July, a Skanska subcontract plant operator manoeuvred a 20t excavator past a weight limit sign into an area restricted to 8t.

The plant stopped at this point, as can be seen in the photograph opposite and did not encroach onto the bridge structure itself.

Photo taken at time of incident.

In order to restore confidence in us by the customer, the Project Manager, immediately carried out a site briefing, attended by all on site, and installed a controlled barrier entry system to prevent a re-occurrence.

- All personnel reminded to adhere to site restrictions at all times.
- All personnel reminded that the bridge is weak. – Which is why we are there in the first place!
- Site restrictions to be included in the site induction.

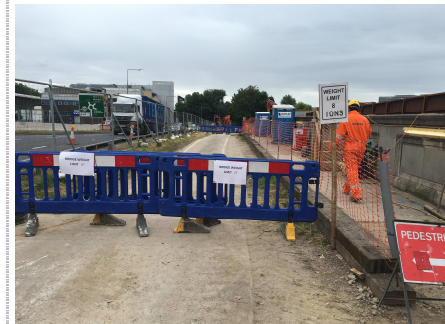
Post incident control
