◀ HEALTH & SAFETY ALERT ▶

Non-Crossrail: Grade 10.9 Bolts

Date: 10th March 2016

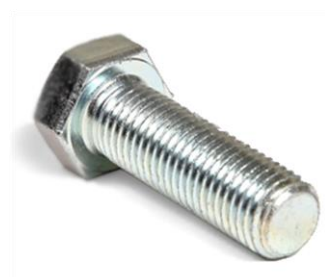
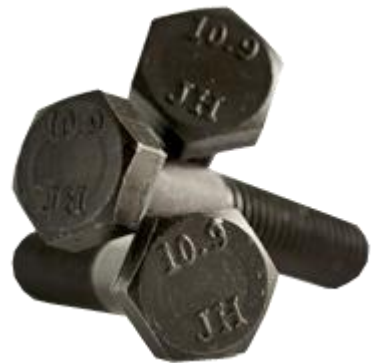
A Non-Crossrail high potential incident occurred when Grade 10.9 high strength holding bolts failed on a crane base on a project in London.

16 bolts, which had been pre-tensioned in the standard way on a crane base, later all failed within four days. This was found to be a brittle failure and because the bolts were pre-stressed, they failed in a manner which released energy, resulting in the bolt heads ejecting to 4m above the lifting frame.

It is believed the failure was due to a recognised phenomenon called 'delayed hydrogen embrittlement failure', which can be caused in the manufacturing process. This type of failure would be expected to occur within a few days of tensioning bolts as was seen in this case.

- Bolts of Grade 10.9 or higher to be approved by technically competent person(s) prior to use.
- Hardness and tensile tests to be used as a minimum to verify the metallurgy of all Grade 10.9 bolts.
- Permits to include the need for technical sign off.
- All using this type of bolt to be briefed on this incident.
