# ◀ HEALTH & SAFETY ALERT ▶

## Multi-Jet Pump Fire

Date: 21<sup>st</sup> March 2016

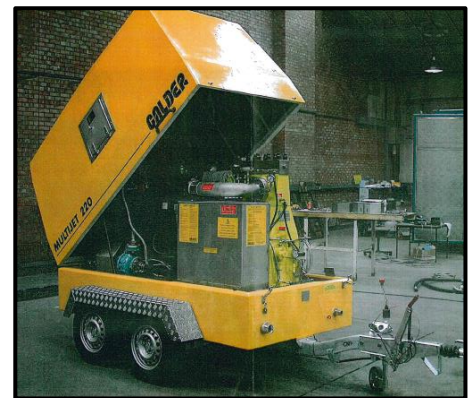
On the 29<sup>th</sup> February at C350 Pudding Mill Lane, a multi-jet pump caught fire when it was being used for Hydro-demolition works. Attempts to extinguish the fire with fire extinguishers were unsuccessful; however the fire was extinguished using water from the nearby hydrant.

Multi-jet pump before and after fire

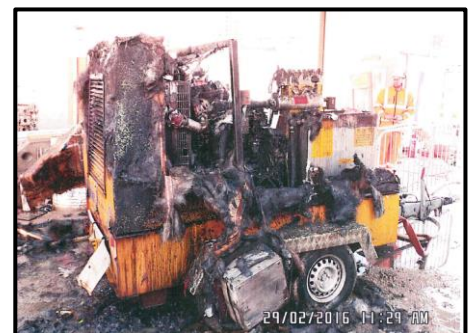
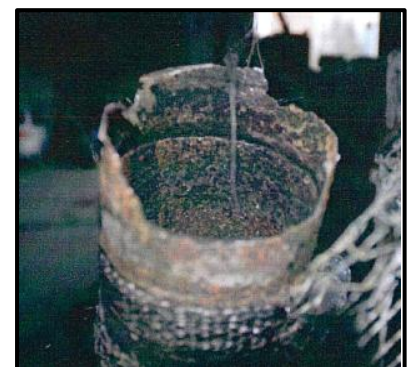
The fire was caused by a catastrophic failure of the exhaust system which ruptured the flexible coupling. This allowed hot gases to rapidly escape and accumulate under the GRP (Glass Reinforced Plastic) hood.

Upon investigation of the incident, the owner of the pump provided copies of maintenance logs dating back to 2012, which were detailed and thorough. Despite this high level of maintenance, problems with internal corrosion in the exhaust system had not been identified.

Exhaust showing corrosion

- All sites to acknowledge similar failures of the exhaust could happen in any other similar piece of plant.
- Consider periodically dismantling exhaust systems in similar plant/machinery to inspect the internal integrity of individual components.
- All sites to consider conducting a survey to determine how much plant of a similar nature and usage could be affected by similar conditions.
- Due consideration must be given to the siting of equipment or plant that contain GRP due to its highly flammable nature.
