## ALERT

### Scaffold Handrail Failure Incident

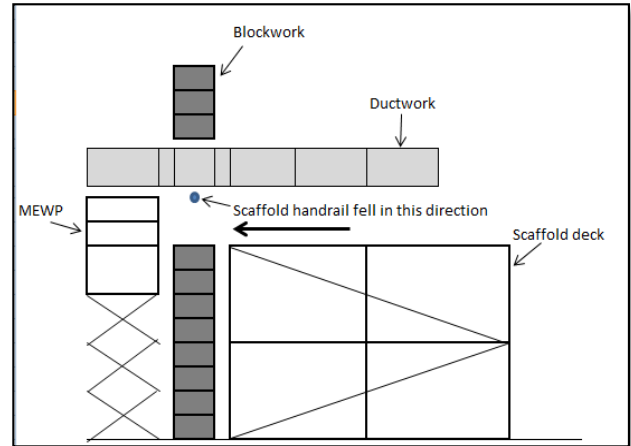
A single handrail had previously been erected between the blockwork opening, which was erected to prevent falls into the opening from the MEWP side. The handrail provided protection in one direction but not the other (scaffold deck outwards) due to its configuration.

*Diagram of incident*

As the ductwork was being installed through the gap the operative on the scaffold deck side of the wall leant on the handrail for support and the handrail gave way. The individual was physically stopped from falling by his colleague in the MEWP directly in front of him.

- All adaption's to scaffolding handrails and decks should take into account previous uses to ensure they remain fit for purpose.
- Competent scaffold inspectors should be used to keep a consistent review ongoing.
