High Potential Incident Alert - 187

Failed ballast line in FPSO crude oil tank

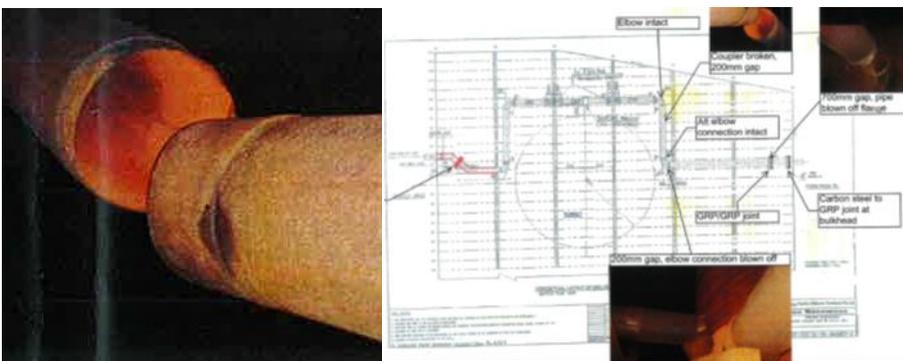
A ballast pump eductor test found that the glass-fibre reinforced pipe ballast line in one centre crude oil tank (COT) had failed. Crude oil entered the ballast system and accumulated in one of the ballast tanks.

An estimated 20 litres of crude oil was discharged overboard and an estimated 200 cubic metres of oil entered the four-port ballast tank.

- Adequate design of the ballast system piping to accommodate the turret when the tanker was converted to FPSO.
- Sufficiently detailed procedure for conducting the eductor test, in particular highlighting the hazard potential of water hammer and its impact on GRP.
- Adherence to operating procedures
- Quality of installation of the GRP piping

- A detailed review and analysis of the ballast piping system was necessary.
- The GRP piping installed in 1C COT must be replaced and the integrity of GRP piping installed in 2C COT must be assessed.
- Procedures for the ballast system must be revised.
