High Potential Incident Alert - 189

March 2016

Use of incomplete lifting gear

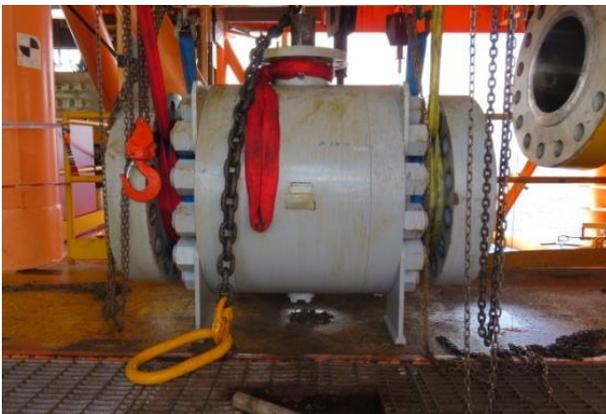
During the removal of a motor-operated valve (MOV), the securing mechanism (two nuts) on a 'P' rigging screw at one end of the spreader bar being used to lift the valve failed when the nuts stripped/pulled off the screw thread.

This resulted in the rigging screw pulling through the spreader bar and the 7.5-tonne MOV dropping about 0.3 metres to the decking on the platform.

Rigging at the other end of the spreader did not fail and remained secured to the valve. There were no injuries nor any damage to the valve or platform.

Incomplete rigging had been provided to the work crew – not all items specified on the rigging drawings were procured.

The goods receipting processes did not identify this short-fall.

Rigging components used to fill the short-fall were gathered on board the platform – this resulted in imperial nuts being inadvertently fit to a metric rigging screw.

The change in rigging components was neither identified nor communicated outside the immediate work group.

Robust procurement and goods receipt processes must be applied to all purchases.

Ensure that any changes to rigging arrangements are identified, communicated and subjected to appropriate review and approval.

Ensure that appropriate rigour is applied through supervision and work authorisation (PTW) processes to identify and prevent work deviating from the plan.

Promote and maintain an open culture such that any deviation from plan results in a universal application of an "Authority to Stop an Unsafe Task".
