# High Potential Incident Alert - 190

## **Corroded grating on Monotower**

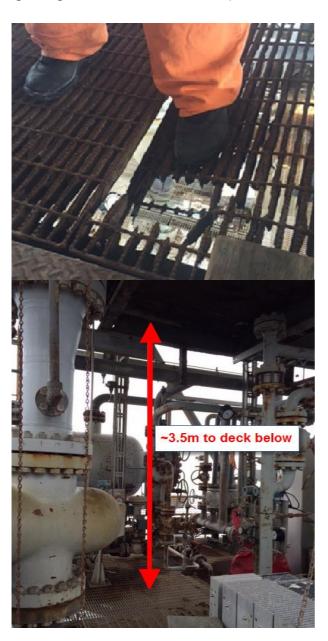
A crew member was visiting the normally unmanned Monotower facility when his foot went through a badly corroded walkway grating.

Pieces of grating fell about 3.5 metres to the deck below and one corner of the grating panel dropped several centimetres.

While this was unlikely to result in a fatality, if any personnel had fallen through the grating to the deck below they could have been seriously injured.

There had been an extended period between visits to this facility, and the hazard had not been identified.

Visual inspection of other grating on the facility was undertaken.

All grating is now monitored for corrosion.

The frequency of visits to unmanned facilities has been reviewed.
