HL01F05 – SHE Lessons Learned

MC300 Rotary Rig Over Turned			
Authorised by:	James Dobson	Date: 24 th May, 2016	
Distribution:	eight₂O and Contractors - TW Health & Safety Hub

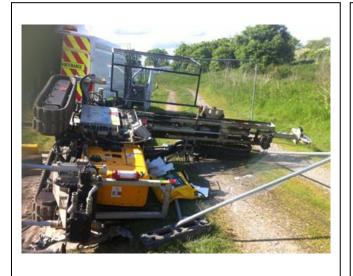
An eight₂O surveying company were setting up a Comacchio MC300 hydraulic rotatory drilling rig to ascertain ground investigation for survey works. Two operatives were in the process of setting up the rotary drilling rig, weighing 2.7 tonne when it over turned.

Although no one was hurt, there was potential for a member of the team to be crushed. The spillage from the rig was promptly contained by the operatives using the correct prevention methods.

The first part of the borehole had already been drilled using the percussion rig whereby the rotary rig had to be setup exactly over the temporary steel casing to position the rig for drilling. The lining is usually set at 35cm but in this case was set at 50cm – 15cm higher than the recommended height. As there was no defined way of lining up their rigs, the methodology and positioning of the mast was not stated within the RAMS. This left operators with varied answers on how the mast should be positioned while the rig is lined up.

On retracting the front left jack to place extra wood under the jack leg, the drill head was off centre which allowed a shift in the centre of gravity causing the rig to overturn onto the ground. The subcontractor's site supervisor was focused on technical and quality issues as opposed to site supervision.

- Ensure expectations are agreed for required supervision at critical phases of operations;
- Ensure all RAMS are adequate and have clearly written safety instructions for work being completed on site;
- Ensure a better understanding of the limitations of equipment deployed and the requirements for increased planning;
- Readiness Reviews form an essential part of all phrases of work (including survey) and must be implemented by all project teams;
- The subcontractor will help to share learning from the incident by briefing the CA JV FLS Forum.
