SAFETY ALERT – FAILURE OF EMERGENCY STOPS

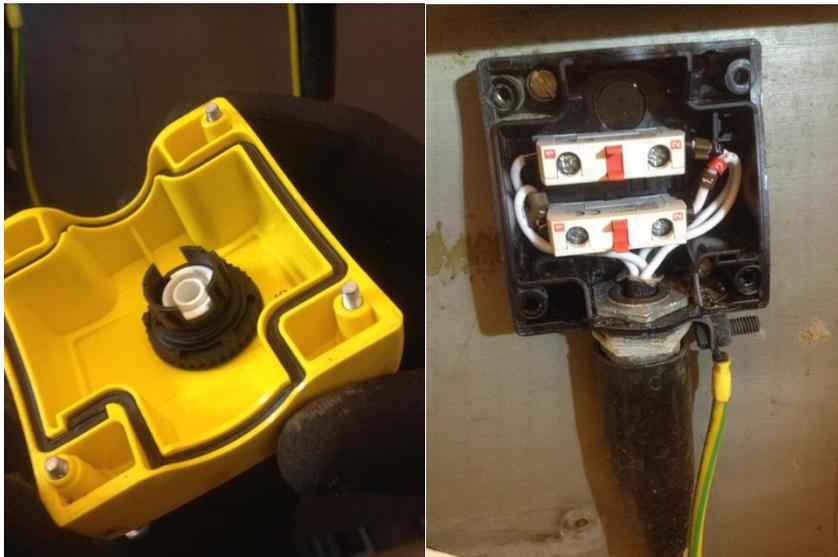
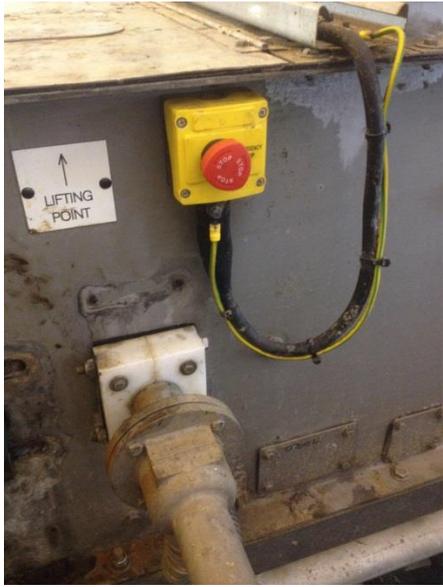
During maintenance, a precautionary test was carried out on the Operation of the E-stop buttons on the Gravity Belt Thickeners at Crossness STW. The Emergency Stop button failed to stop the Gravity Belt. Upon investigation it was found that the Emergency Stop button lid can be rotated 90 degrees and installed, such that the button lugs fail to engage the lugs, which will open the electrical contacts.

Further testing of the adjacent belts also revealed that these had the same installed issue. Investigations are ongoing to determine how this fault arose and what checks were made during the commissioning of the belts. Since this issue arose at Riverside it has been reported they have experienced issues with the contact blocks parting from the box in the past.

All site managers with Alfa Laval Simon-Hartley supplied Belt Thickeners need to check the operation of the Emergency Stops.

Representations to the supplier are being made to improve the design such that the lids containing the stop buttons cannot be rotated, upon installing the cover.
