## Alert – High voltage cable strike

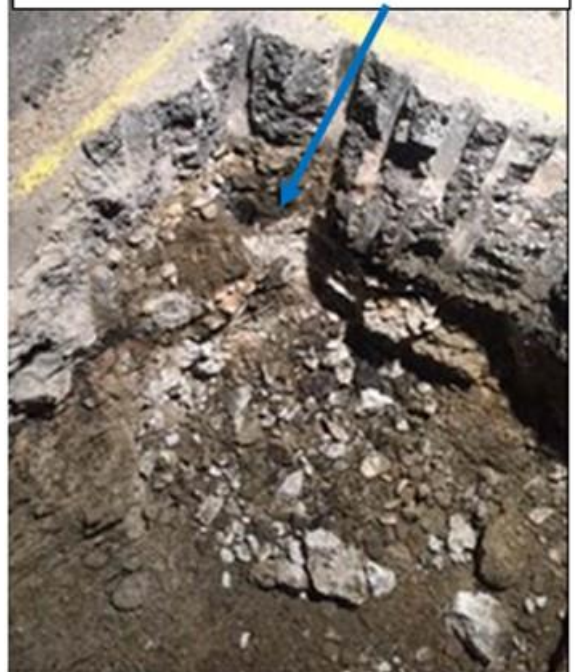
There has been a recent high voltage cable strike where one of our operatives struck a cable with a handheld breaker. There was a small flash but this did not result in any injuries.

The cable was known about, traced and marked up, and the operative struck it when trimming up the edge of the excavation

Hole where the hand held heavy air breaker struck the cable

- Where services are found to cross the marked excavation area do review to see if excavation size or location can be moved or adjusted to avoid exposing the service
- Ensure the risk assessment is developed for the specific activity/excavation rather than the overall project
- Ensure exclusion zones are identified, marked and implemented
- Install physical barriers if necessary to remind and stop persons working near live cables
- Only use mechanical plant outside of exclusion zone, and this includes powered hand tools
- Start excavating from a 'safe' area and utilise under digging methods to check for services before breaking top surface
- Always wear flame resistant & arc resistant PPE when working around or near services and keep your sleeves down
