**SAFETY**

## Concrete skip discharge sleeve near miss

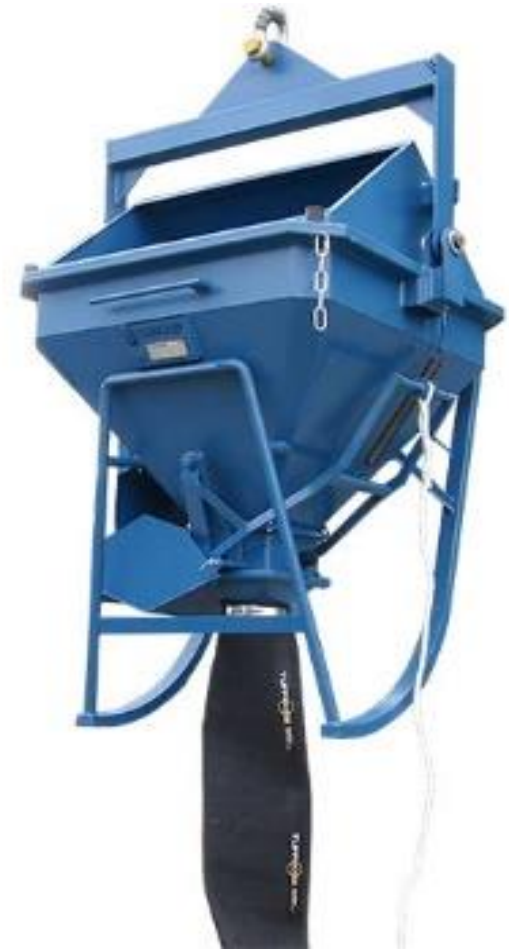
The employee who was assisting in the pouring of concrete by leaning his left shoulder against the sleeve to prevent the concrete building up was struck by the sleeve as it detached and fell to the ground due to the jubilee clip not being correctly attached.

The employee was knocked to the ground but got up immediately without sustaining an injury and returned to work immediately. Upon inspecting the concrete skip, it was clear that the clip had not been tightened. The concrete skip was brand new and had only been delivered to site the previous day. Upon reporting the incident to the supplier (Conquip) a new skip was delivered to site on the 15<sup>th</sup> December 2016.

When carrying out the initial inspection on the new concrete skip, it was clear that the jubilee clip was again loose and had to be tightened using a torque wrench.

Type of skip being used at time of incident

1. Inspect all equipment prior to use ensuring all attachments are secure.
2. Inspect all concrete skips on site and ensure discharge hoses are adequately secured.
3. Notify supplier of defects to ensure plant supplied in future is fit for purpose
4. Ensure all accidents are reported to site management in a timely manner.
