# SAFETY ALERT

## Driver loses control of light vehicle and crashes in underground mine.

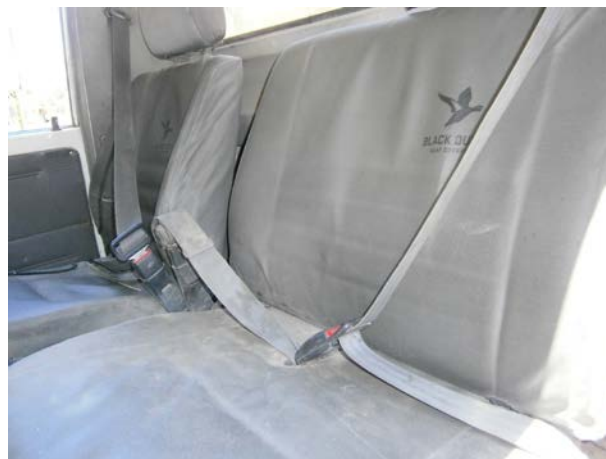
This type of vehicle is commonly supplied with a bucket seat and lap/sash seatbelt for the driver, and a "three quarter" bench seat for passengers with a lap/sash seatbelt for the passenger near the door and a lap belt only for the middle passenger.

*Photo: Seating and seatbelt arrangement.*

The investigation concluded that the cabin of the vehicle was not equipped to safely accommodate three people and this contributed to the transmission being knocked into neutral, and to the failure of the driver to properly control the vehicle.

1. Mines should conduct a risk assessment for the operation of personnel transport vehicles to determine the number of passengers that can be carried safely in the cabin, in a manner that will not pose a risk to the proper control of the vehicle by the driver.
2. Mines should ensure that all passengers carried in personnel transport vehicles have access to seats and seatbelts that are suitable for the level of risk and provide a level of protection that is equivalent to that provided to the driver.
