Safety Alert

ALERT 15-06

CAUGHT BETWEEN WINCH TRUCK & HALF PIT

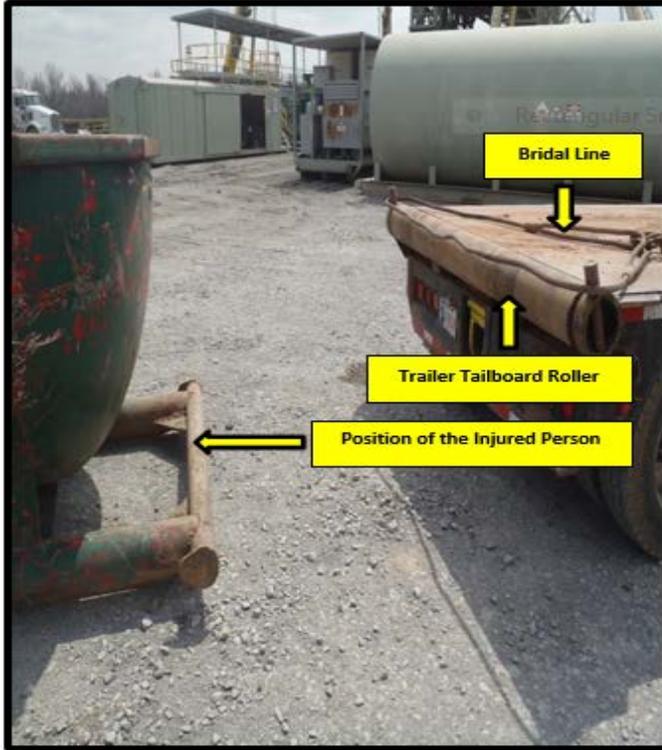
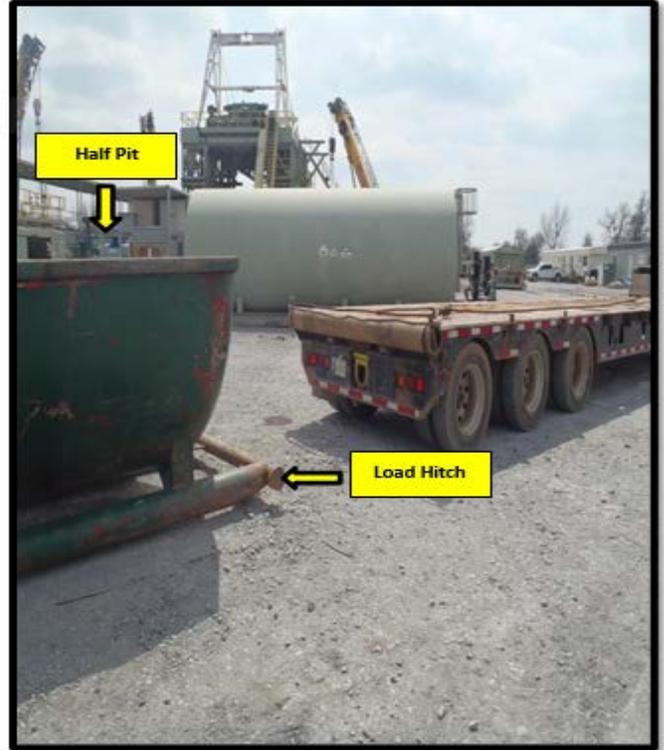
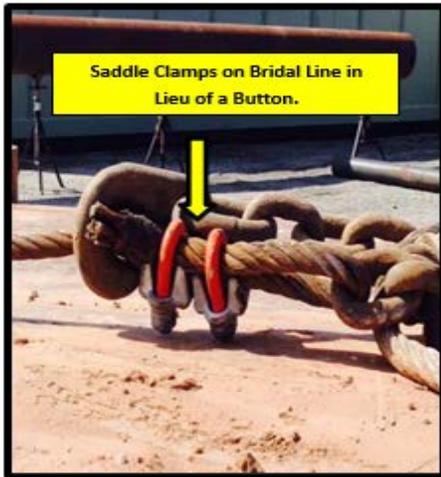
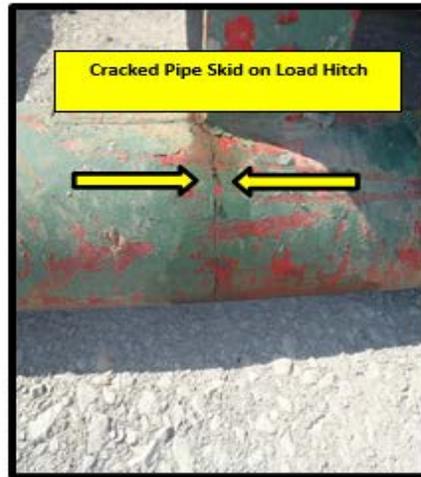
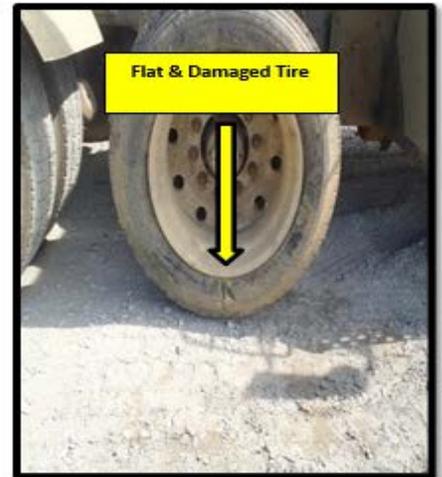
The IP then squeezed himself between the trailer tailboard roller and half pit trying to get to the driver side to release the airbag controls. At the same time, the driver had the truck in neutral with one foot on the truck brakes and one on the clutch so he could engage the winch and tighten up the winch line. While the driver was looking down to engage the PTO, the truck rolled back (presumably because the driver let his foot off the brake) and ultimately pinned the IP between the trailer tailboard roller and the half pit. Both the injured person and the other swamper started to yell for the driver to pull forward. As the truck pulled forward the swamper stepped in to hold the injured person up and yelled for help. Additional help immediately arrived and assisted to lay the IP on the ground. Basic first aid treatment was provided while waiting on the ambulance to arrive.

- All personnel involved must agree and understand the necessary steps to be taken to complete a task safely. Known hazards of the task and how to mitigate those hazards shall be followed. The injured person was aware of the hazard but chose to ignore it and take a short cut to complete his task. Following the standard order of operations and calling for a "STOP THE JOB" when the plan deviates away from or out of order is a requirement and shall be followed by all personnel.

- The personnel involved in such tasks shall remain in constant communication both verbal and visual. The truck driver did not verify that his swamper's were clear and at a safe distance from the truck as he prepared to pull away from the load.
