ALERT 15 - 09

NEAR MISS – DROPPED SIX POUND SLEDGE HAMMER

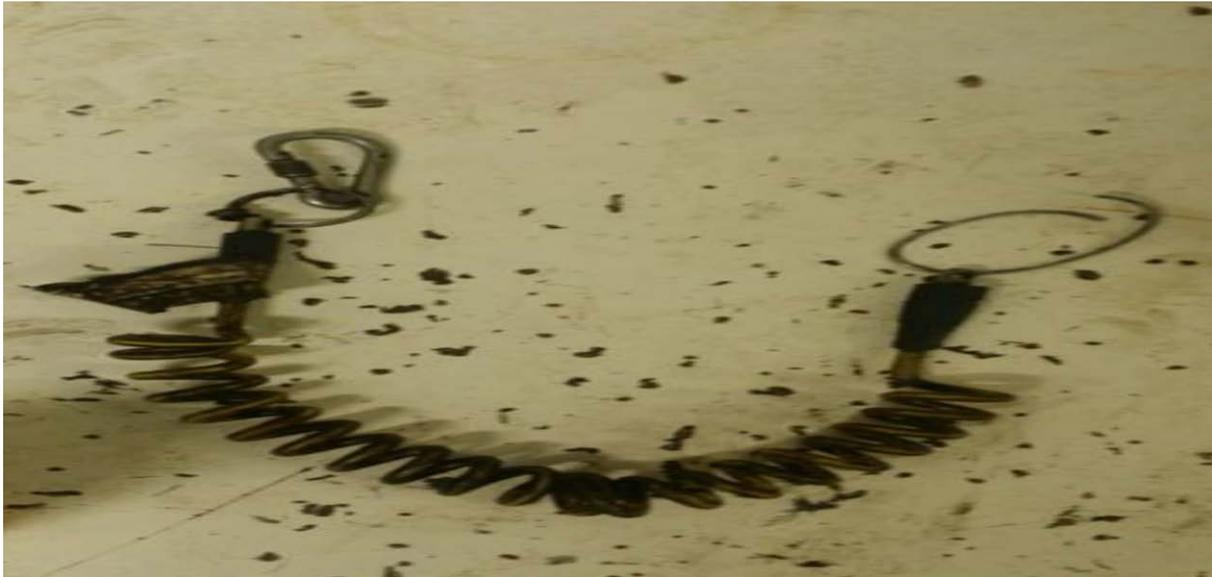
During drilling operations it was noticed that the vibrating hose connecting the sections of stand pipe between the strong back and mast stem was leaking. The rig shut down and removed the damaged vibrating hose while waiting for a replacement to arrive on location. Prior to installing the replacement hose, the derrickman retrieved the stop drop tool kit and other required tools. A six pound sledge hammer with a tethered tool lanyard was selected and clipped to his boatswain belt; he then raised himself into position with the "man rider." While being raised the sledge hammer hung up under a mast girt causing the ring on the tool lanyard to fail, this allowed the hammer to fall approximately 20 feet to the rig floor. The hammer landed by the iron roughneck, about 10 feet away from the flagger who was positioned on the driller's side of the setback area.

The hammer was not properly stowed to the body while being raised into position. The derrickman nor the spotter noticed the hammer hung under the girt while being raised into position.

Tool lanyard with broken ring

Hoisted personnel shall properly stow the tools to their body while being raised into position. A small carabineer can be secured to the harness and the working end of the tool should be fastened to the carabineer via the tethered lanyard while being raised into position. The tool shall not hang below the hoisted person. More than one spotter may be necessary when a person is being hoisted throughout the mast. The drop tool kit is equipped with a tool bag that could also be used to stow the tools until reaching the desired working position.
