# SAFETY ALERT

## Opal miner injured by falling material

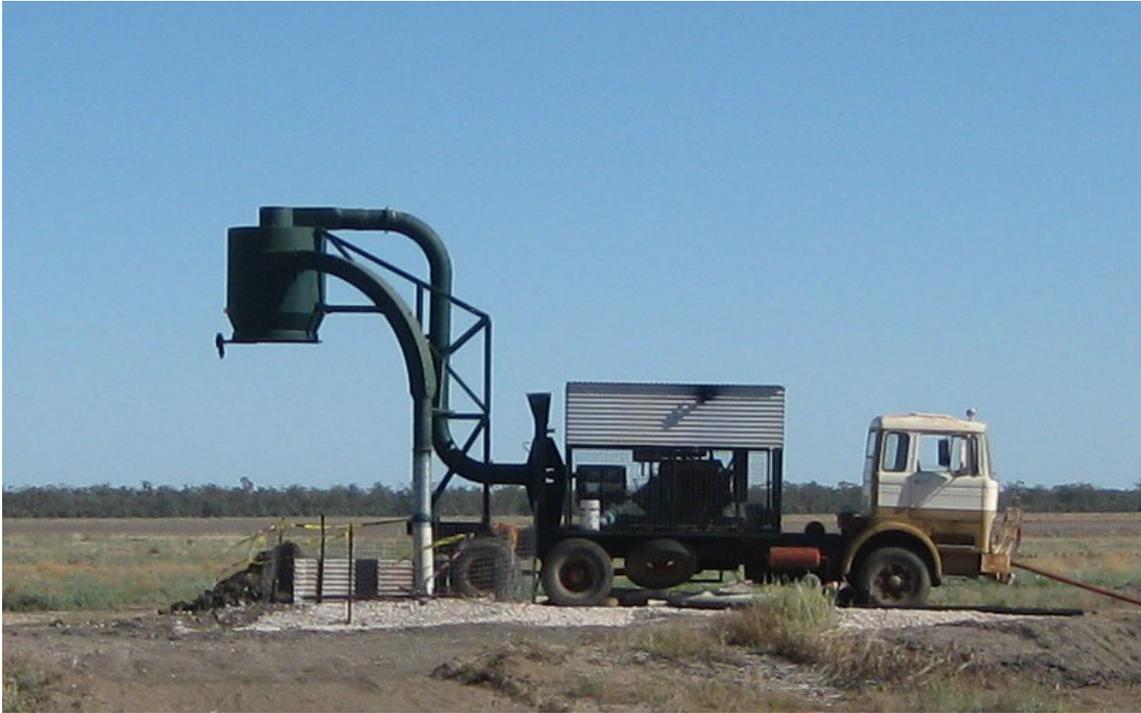
Figure 1: The truck mounted blower and hopper involved in the incident. Photos by Mine Safety.

- Ensure that a risk assessment is carried out before undertaking unfamiliar tasks.
- Assess the potential for rocks and debris to fall and cause injury.
- Where there is any potential for material to fall from a height which may result in injury, take effective means to prevent such injuries.
- Any area where materials can accidentally fall onto people should be classified as a danger zone and appropriate guards and warning signs must be provided.
- Ensure workers are trained and competent in the use of blower extraction systems.
- Ensure that equipment being used is fit for purpose.

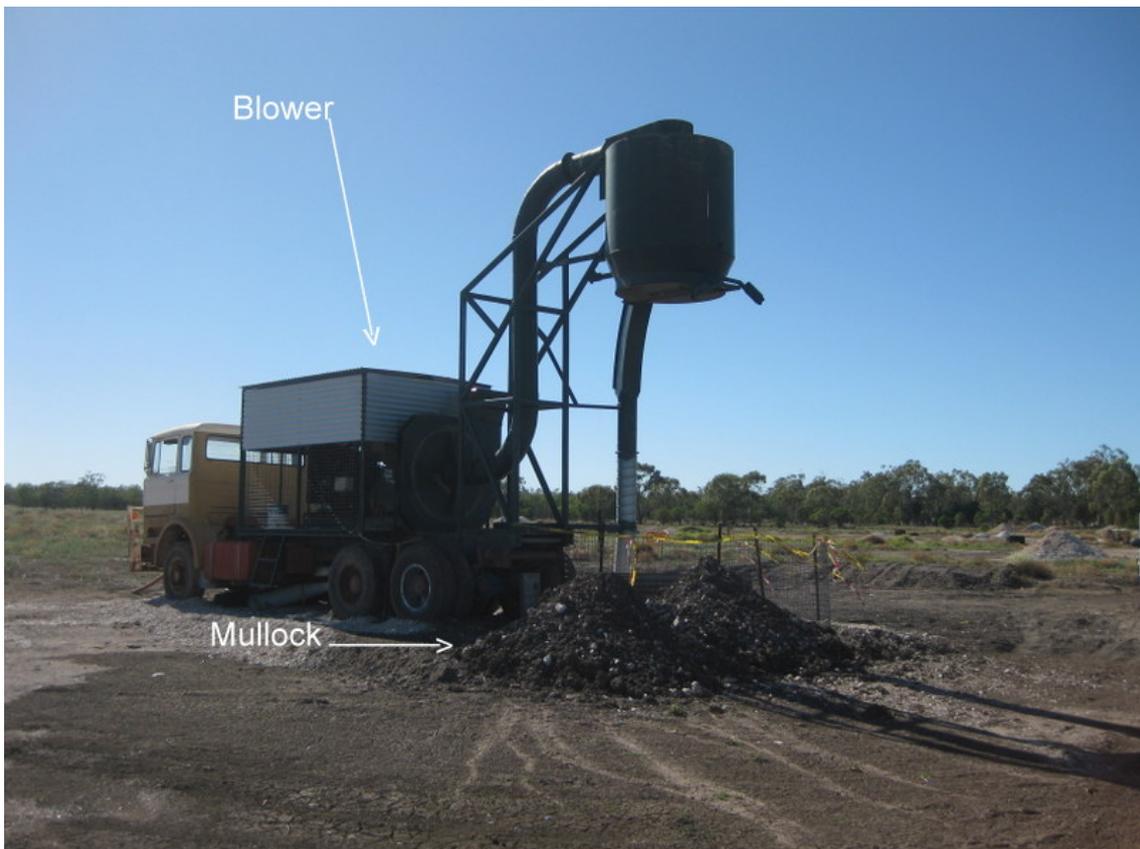
The worker was investigating a hopper door malfunction on the surface at an opal mine. The worker used a star picket to push the door closed when material ejected from the hopper, striking him.

Figure 2: The truck mounted blower showing where the mullock fell. Photos by Mine Safety.

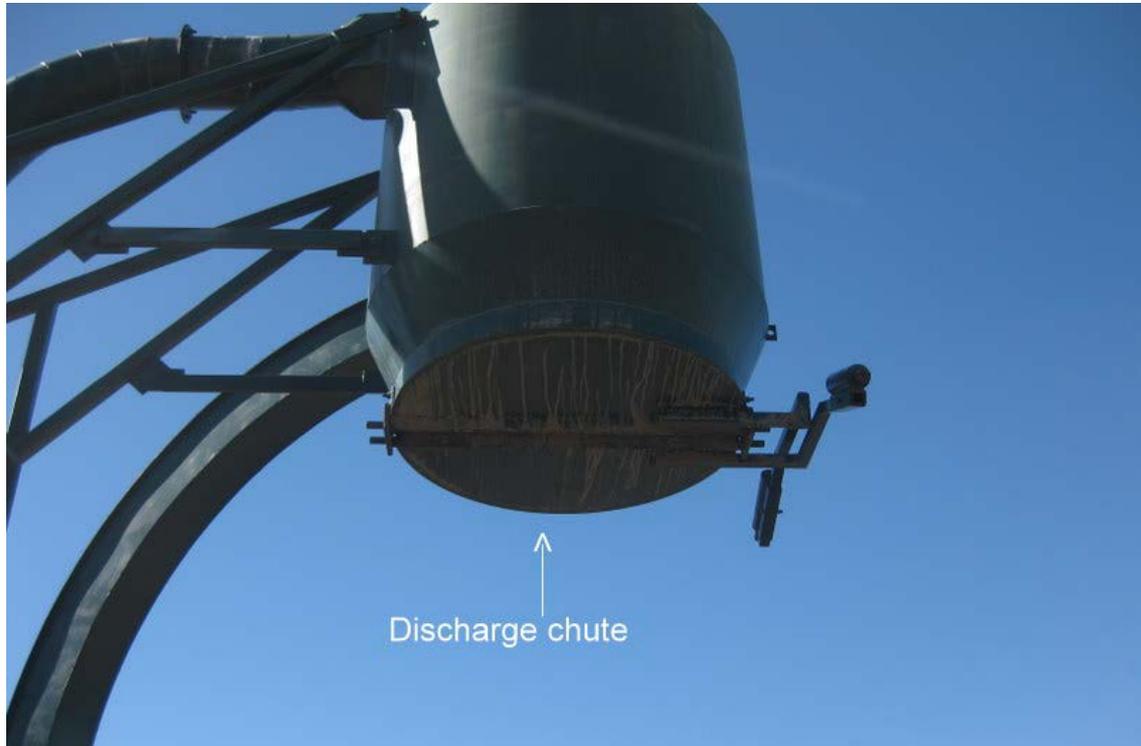
Mine Safety inspectors examined the hopper and found that the refuse material was moist and caused a build up inside the walls. This in turn caused the exit door to jam open and not seal correctly.

Figure 3: The hopper involved in the incident showing the discharge chute door which failed to seal. Photo by Mine Safety.

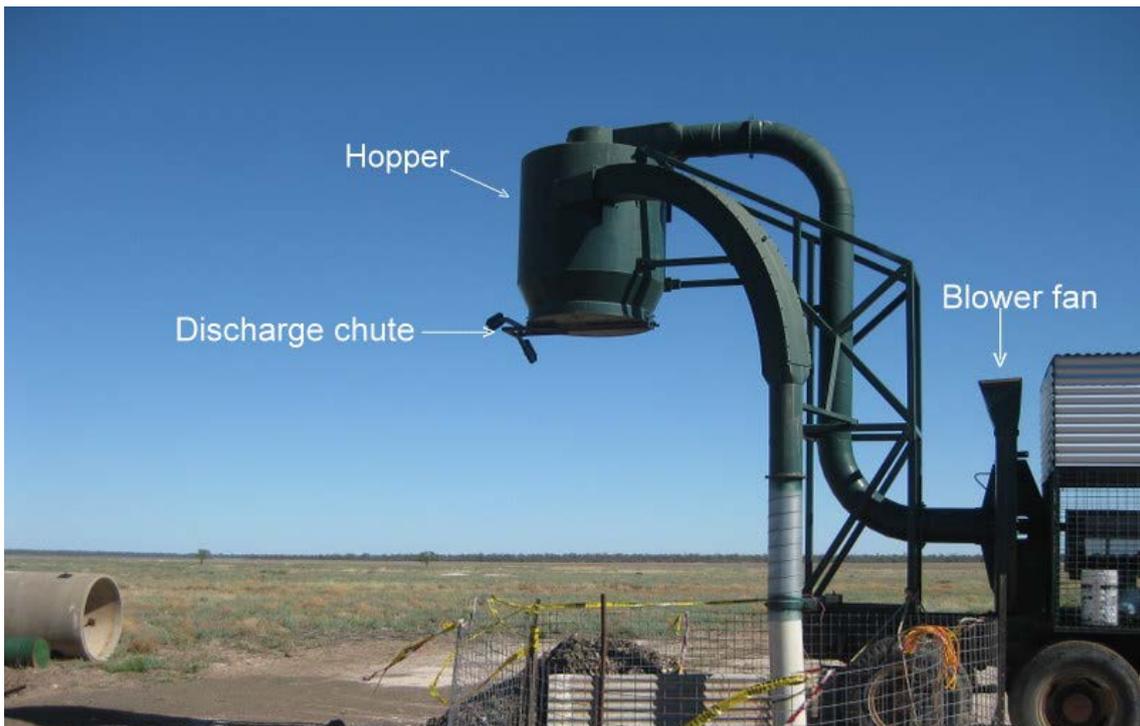
Figure 4: The hopper showing the discharge chute door. Photo by Mine Safety.
