# SAFETY ALERT

## Operator suffers broken arm while operating high pressure hose

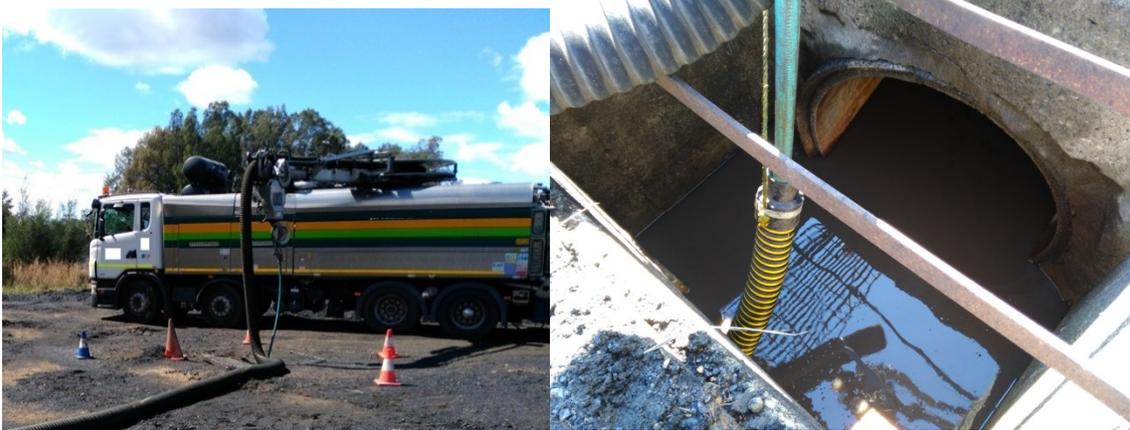
Two people were performing the task on 21 September 2016. The operator of the pump was "walking" a jet hose into the drainage pipeline through a surface pit, while an assistant held a rope (tiger tail) attached to a sheath protecting the hose as it was inserted into the pipe.

The hose was pressurised to approximately 1500psi. The pressure in the hose caused energy to store. It had been inserted about 20 metres into the pipe when a loop in the hose caused it to "whip" towards the assistant and hit his left forearm.

Figure 1: High vacuum pump (left) and Figure 2: The drainage sump (right). Photos by a Mine Safety inspector

The investigation identified that the process of “walking” the hose into the drainage pipe was a significant contributing factor to the hose looping and releasing the stored energy in a violent manner.

1. A risk assessment and safe work method statement must address all aspects of tasks involving high pressure hoses, including the working environment and the potential for hose loop occurring.
2. Placing a high pressure hose on the ground poses a significant “looping” hazard and should not be normal practice.
3. The “walking in” of a hose poses a significant risk to people and should not be normal practice. Eliminate uncontrolled feeding of a pressurised hose.
4. Effective and understood exclusion zones are to be established before work activities commence. These zones should be physically delineated.
5. Review the publication [Managing risks from high pressure water jetting](#), prepared by SafeWork Australia, December 2013.
