Excavator Counterweight Strikes Worker

Safety Alert

Issue #:13-2016

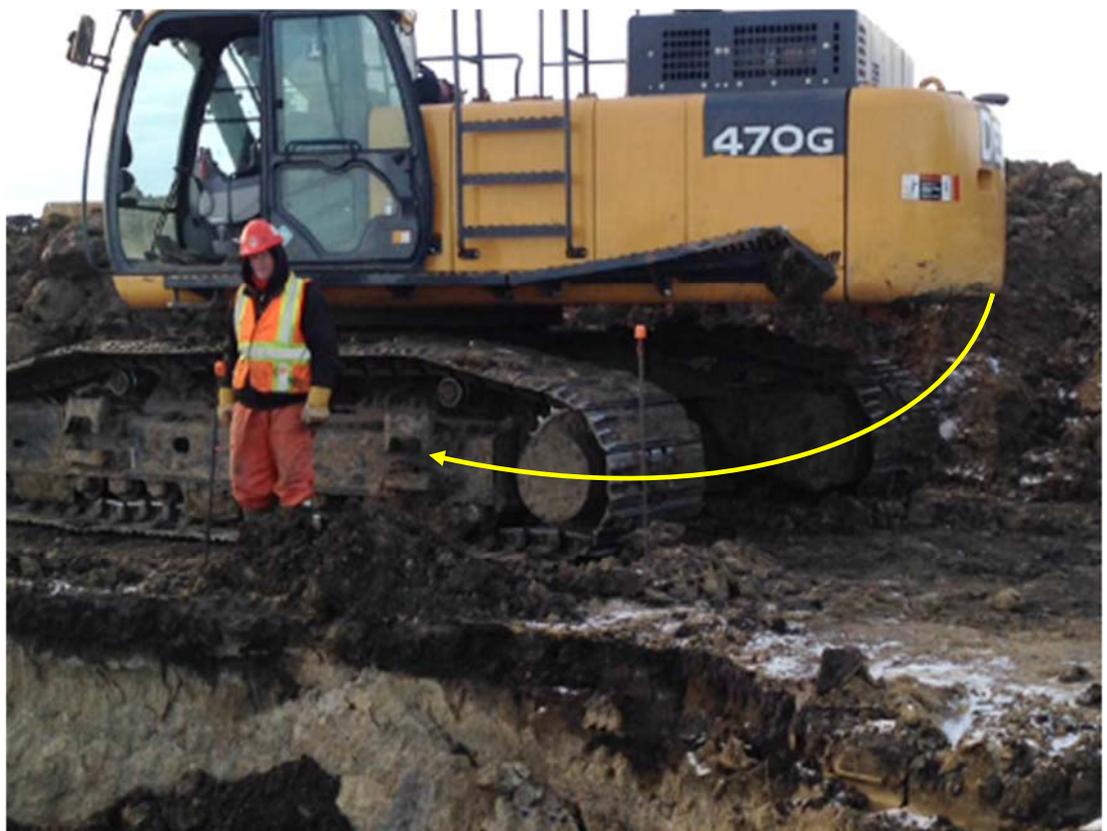
While an operator was performing excavation operations, a co-worker moved to the edge of the ditch to observe the work progress. The worker inadvertently placed himself in the excavator's swing pivot zone and the operator's blind spot. The worker did not effectively communicate his intentions to the operator and did not confirm that they were understood. When the excavator operator removed the bucket of dirt and pivoted, the counterweights of the excavator struck the worker's shoulder. The worker fell approximately 1.5 meters into the ditch and then rolled approximately 1.5 meters onto the exposed pipeline. Despite the high potential for significant injury, the actual consequence was less significant with the worker suffering a scrape to his forehead.

Excavator and Injured Worker Position (re-enactment)

The worker stepped into the excavator's 10 meters (30') swing pivot zone.

- Failure to identify hazard/lack of situational awareness
- Not following procedures
- Poor communication and planning

- Within 10 meters (30') of operating equipment (or greater depending on the operating reach of the equipment), prior to entering, personnel must first have their intentions verified as understood and accepted by the equipment operator
- As part of the Operator Competency Checklist, operators must idle down and lower all ground engaging tools if personnel, vehicles or other equipment encroach within 10 meters (30') of operating equipment
- Equipment approach procedures and operator blind spots for equipment must be reviewed during the Field Level Hazard Assessment (FLHA) before work starts
- Use a spotter when operating equipment in congested/restricted areas
