IA Team Standdown

14th June 2016

Outline of Incident on 9th June 2016

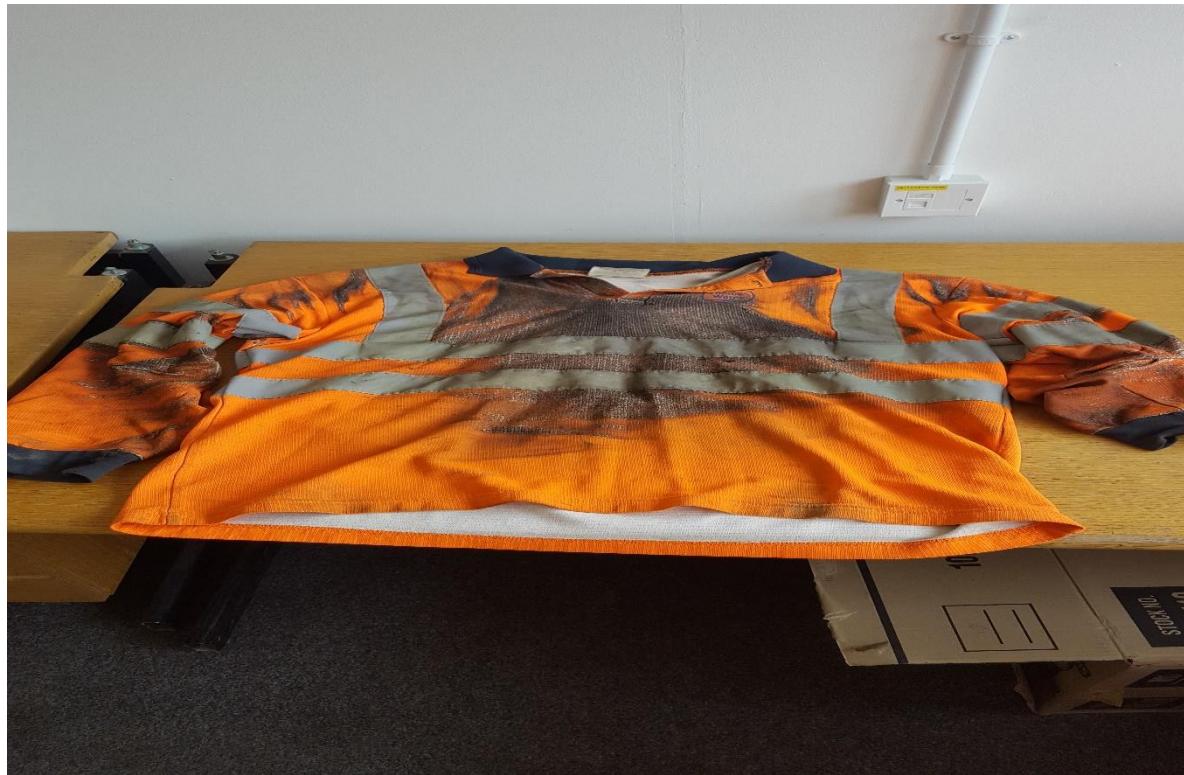
The Shirt took the brunt of the flash. No damage to the inside of the shirt

- The PPE worn during the incident all worked as designed.
- No burns to legs or chest due to the flame and arc resistant clothing.
- LEP protected the eyes of both operatives
- As we approach summer, do not be tempted to roll or pull up sleeves
- Gloves are to be worn at all times

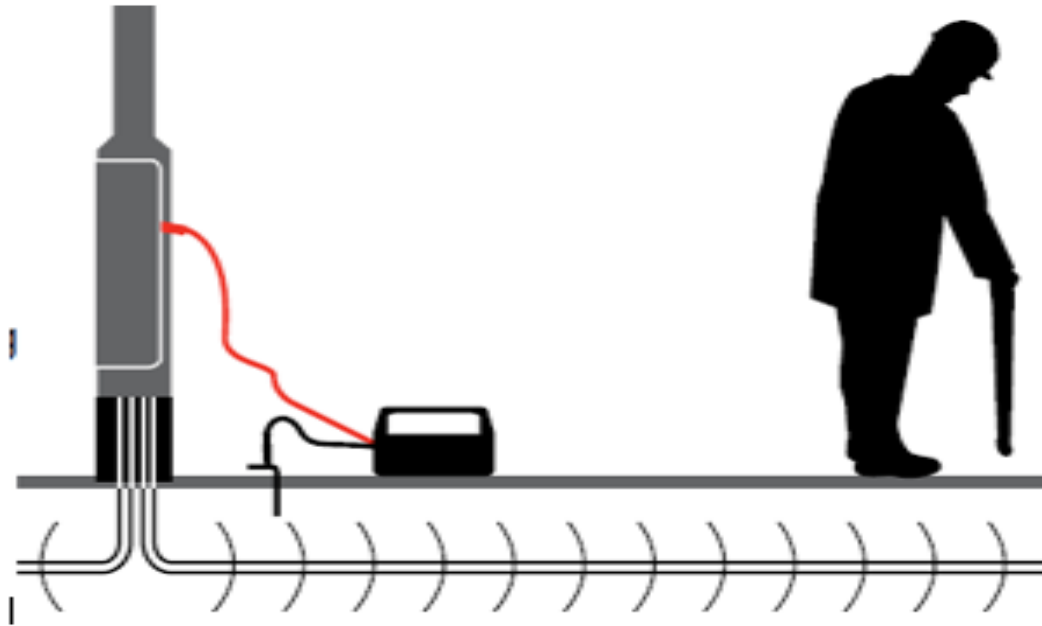
CALM

Always mark up your findings from your scan

- Ensure that CAT & Genny is used before and during dig to locate all services in the area
- Ensure that a full scan of the area is completed including scanning through the excavation to locate any services that may effect your excavation
- Consult drawings before and after scanning area to ensure that all services in the area have been located
- Clearing mark all services and take a photo on SWIMS before dig commences
- Permit to break ground to be completed before dig commences and all operatives on site to have signed it
