# SAFETY ALERT No. SA 02/2016

## UPS Incident

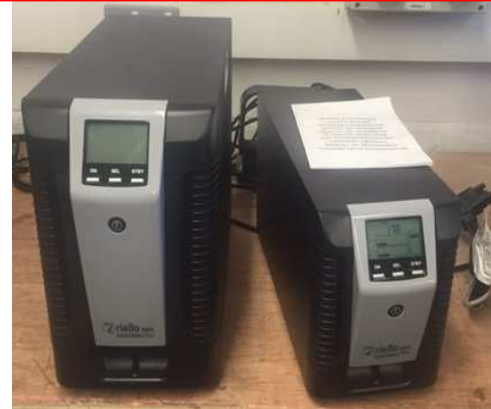
The UPS being installed was a RIELLO Sentinel Pro UPS and battery box.

Riello UPS 72V & 36V

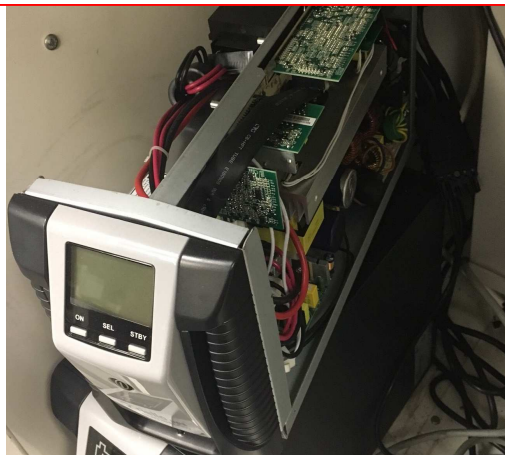
### Damaged UPS

Whilst connecting the UPS to the battery box the production technician noticed a fault code (F60) appearing on the UPS. He then powered down the UPS and continued to disconnect the UPS from the battery box. Whilst carrying out this the UPS exploded and the technician was hit in the chest by the metal casing.

- The UPS was being over charged as identified by the failure code which caused hydrogen and oxygen to be released from the batteries on board the UPS.
- The battery box was 72v and the UPS DC input was 36v at that point the larger battery box rapidly discharged into the smaller battery system on board the UPS.
- The keyed interconnecting cable between the battery box and the UPS was configured to allow the connection between these products.
- The small printed safety manual provided does not mention this potential safety issue or the need to check voltages. This is mentioned within the manual available on a CD provided.

- When connecting UPS systems ensure that nominal voltages are checked to ensure compatibility. **Do not** assume that if the interconnecting cable fits that the products are compatible and safe.
- Always read all the manuals or product information provided before installation.
