◀ HEALTH & SAFETY ALERT ▶

Non-Crossrail - Dismantling of Sherpa-scopic Steps

WORKING AT HEIGHT

Date: 4th March 2016

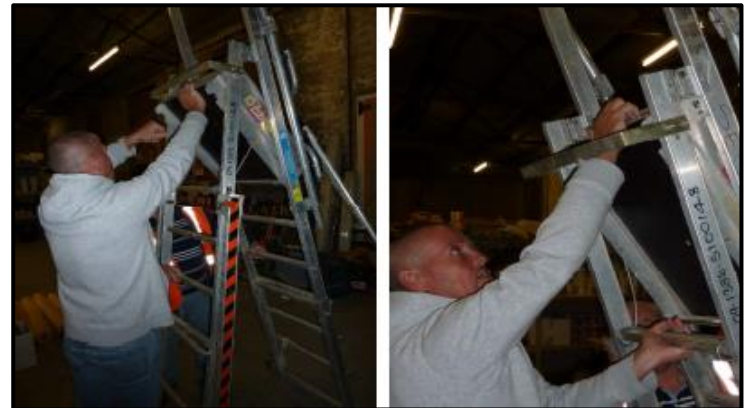
Following the previous [alert](#) relating to Sherpa-scopic steps, a Non-Crossrail incident occurred in which an operative had their forearm trapped between the collapsing base stand and the guard rail of the tower. This was done with the mark 1 model Sherpa-scopic steps.

The investigation found that the lifting base of the platform can allow an operatives arm to be caught under the bar; it is still possible for this to occur with the mark 2 model.

Example of arm caught under the bar, trapping and injuring the forearm

- 1) Two operatives to dismantle, one either side of the tower.
- 2) The operative lifting the base portion to keep their arm clear of the barrier/bar.
- 3) Second operative to control the inward movement of the steps and prevent the tower falling forward.
- 4) First operative to take control and lower the tower to the floor.

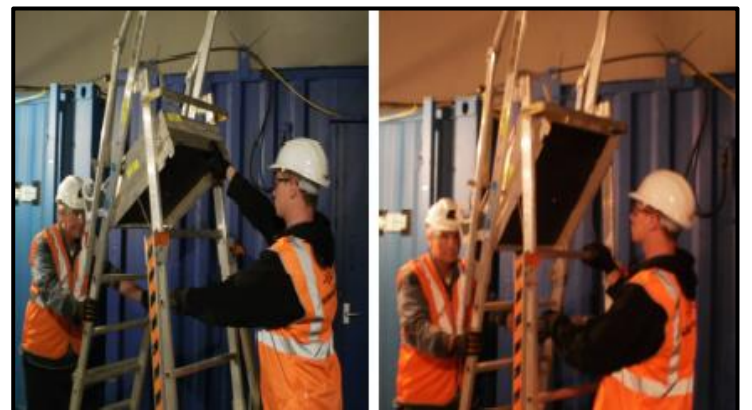
Two operatives dismantling the tower, one either side

Only operatives trained in the use of Sherpa-scopic steps should construct and dismantle the towers.

The mark 2 and later, are the only models to be used on Crossrail works.
