◀ HEALTH & SAFETY ALERT ▶

Piling Rig Failure

Date: 25th May 2016

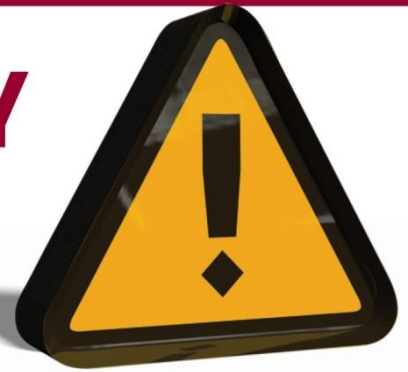
On Tuesday 29th March at C512 Whitechapel, a piling rig suffered a failure to the rod end connection, between a hydraulic ram and the mast. This caused the mast to descend to a position where it was resting on the steel Cable Management System (CMS) above the site hoarding.

Following the investigation into the incident, it was identified that one hydraulic cylinder failed to the side of the piling mast, allowing it to descend.

The rod end thread of the hydraulic cylinder failed as it was worn to the point of failure. A lack of inspection of this component meant this had not been detected.

It was found that this part is particularly difficult to access and is not part of the general mechanical checks undertaken. There are no maintenance requirements on this particular part of the rig.

- All sites to acknowledge similar failures of the hydraulic cylinder could happen on other similar pieces of plant.
- Consider periodically dismantling plant/machinery to inspect areas not part of general mechanical checks, to ensure the internal integrity of individual components.
- Re-assess the frequency of inspection of these types of joint on all similar pieces of plant.
