## ALERT

### Tracked Dumper Incident

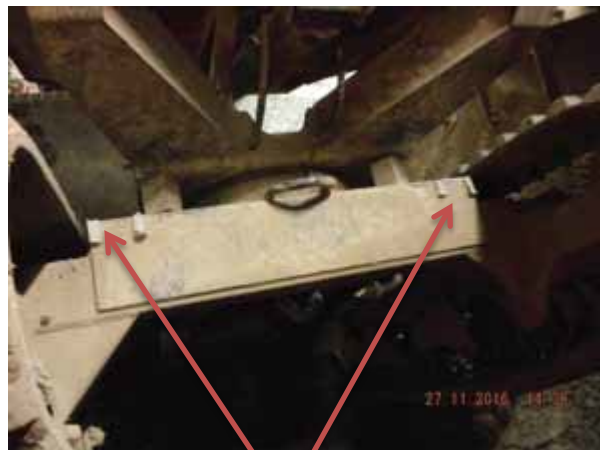
As the dumper reached the brow of the incline, the two eyelets which attached the winch rope to the dumper failed and broke off. The dumper turned to its side and then began to slide down the ramp. As this happened the operator released his seat belt, exited from the dumper and instinctively made his way to the bottom of the incline. The dumper continued to slide down the ramp and came to rest approximately 20 metres lower down the incline next to a raised pedestrian walkway.

Location of eyelets of tracked dumper

- On investigation it was found that the dumper, which had been delivered to site, did not meet the specification of what had been procured.
- The eyelets used to secure the winch to the dumper were not designed for the task, nor were they marked.
- There was no user's manual on site to help instruct the site team on use.
- The project has designed and implemented a new procurement flowchart which will ensure the right item of plant has been delivered. The project has altered its plant acceptance form to further supplement the control measures.
- The project has reinforced the principle of pause and reflect whenever the method changes.
- The project has liaised with the manufacturers regarding the possibility of putting physical controls in place to prevent using wrong attachment points.

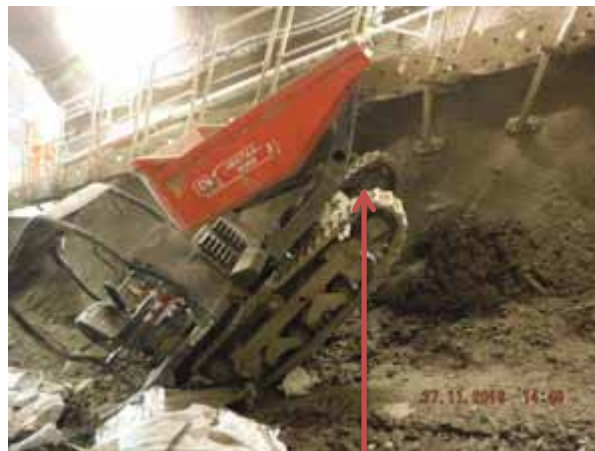
Location of tracked dumper when it came to rest
