HEALTH & SAFETY REF: BULLETIN 230

Incident Removing Penstock

Penstock crushed Field Service Engineer's (FSE) finger

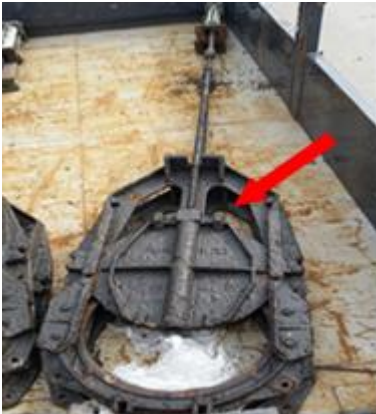
During a shutdown to remove penstocks from an inlet chamber one of the penstocks closed on the FSE's finger during the lifting operation.

The operation to remove the penstock was being undertaken with the assistance of a contract lift. The slings were attached to the hand wheel and headstock assembly through which the penstock spindle is turned.

The Injured Person (IP) inadvertently placed his right hand in the gap between the gate and frame, arrowed, and tugged on the gate, pulling the complete assembly off the remaining studs.

With no means of support, the frame slid down the suspended gate crushing the IP's index finger.

This resulted in a compound fracture to the index finger on the right hand with three other bones also broken on the same finger.

- All parts of a load need to be supported to avoid two parts moving past one another.
