Tank Implosion

Safety Alert

Issue #: 04-2016

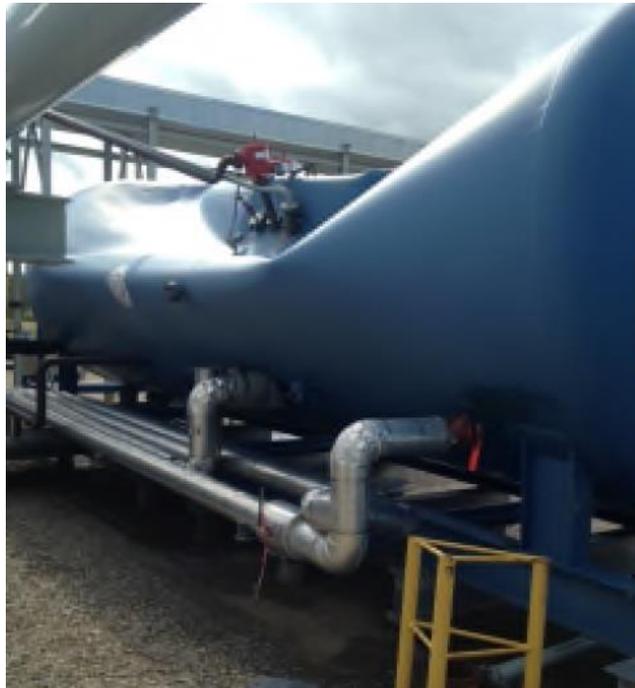
To drain a condensate tank a vacuum truck was connected to the tank's flow line and suction was applied. Negative pressure immediately built up within the tank, causing it to implode. The tank was destroyed.

Imploded Tank

There was no means of equalizing the pressure in the tank when it was placed under negative pressure.

- A review of all production tanks was conducted for the presence or absence of pressure suction release valves.
- The requirement for pressure equalization devices was incorporated into engineering design specifications.
- A review of the facility integrity program was conducted and changes made accordingly.

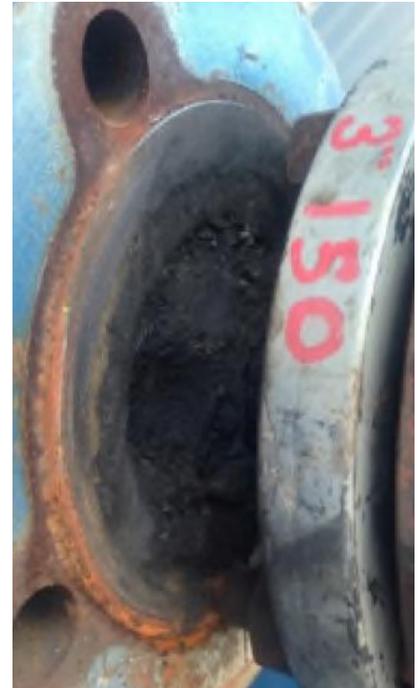
Plugged Flare Line

- The flare line was plugged with paraffin and there was no way for operators to verify its functionality.
- The tank was not equipped with a functional pressure suction relief valve for negative pressure.
- There was no plan or procedure in place to ensure pressure equalization during tank draining.
