Safety Alert 252 : Pump Handle Failure – Flygt 3102

Date: 19/08/2016

Distribution: Thames Water Managers & Contractors

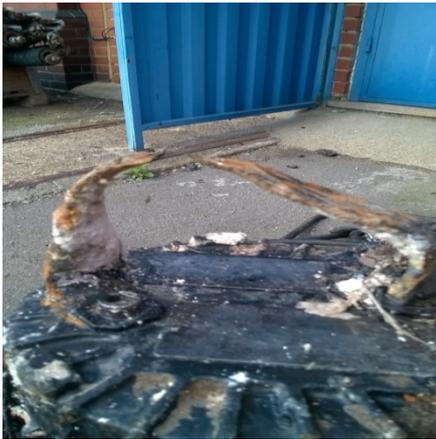
The pump was examined for signs of damage sustained by the fall and during the investigation it was observed that the pump handle had become severely weakened due to the harsh environment of the wet well and had failed.

Having been submerged in sewage within a wet well environment for most of its operational life, the metal had corroded to a point of failure and during the lift, the weight and strain on the worn metal caused the handle to fail & shear which led to the pump to falling.

- Where practicable, wet wells are drained low enough to expose the top of the pumps so that a visual inspection can be made of their condition in-situ and prior to attempting to lift the pump.
- Task lighting is provided to aid inspection of the pumps if adequate site lighting is not available.
- Prior to attempting to lift the pump, if a visual inspection indicates an unsafe lifting handle, it is imperative that a SHE 4 Safe System of Work is devised which identifies a safe means of removing the pump.
- Pumps which can be safely removed are thoroughly inspected and if found to have worn handles they are to be immediately quarantined until a new handle can be procured and the defective one replaced.
