HEALTH & SAFETY ALERT

Overtuned Plant

Date: 3rd March 2016

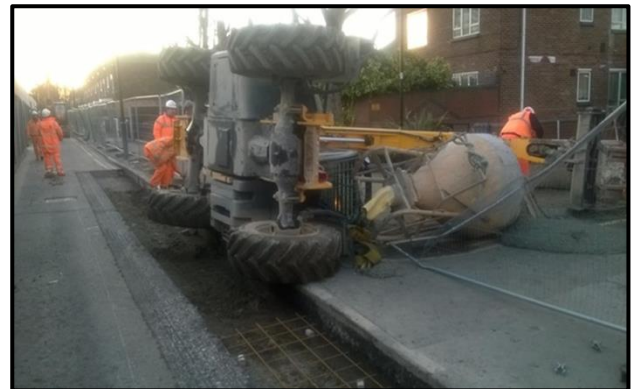
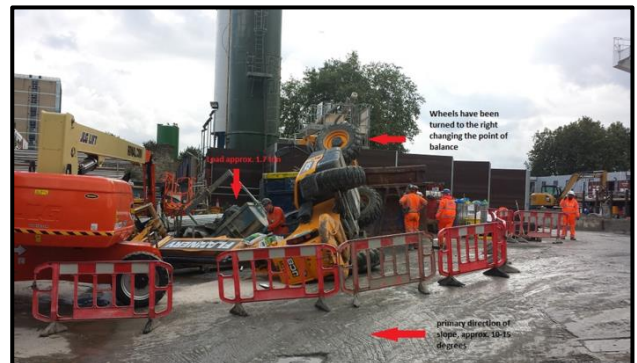
There have been three incidents of plant overturning in recent months, two telehandlers and one 8ton excavator whilst being used as lifting equipment.

The key problem identified is frequent small lifts being undertaken that fall under generic lift plans and rely on the slinger/operators to make key planning decisions.

Two examples of overturned telehandlers

- Ground conditions to be considered at all times, including gradients.
- Project ban of underslung loads on telehandlers until operators have undergone additional CPCS Cat E training (suspended loads) covering this activity.
- Supervisors to be more pro active in stopping work, and reporting activities not covered by the lifting plans.
- All plant to be checked to confirm overloading warning equipment is in working order.
- Load cells to be used to determine exact weight of loads which are stacked on site. Stillages are not to be over stacked with items.
- Loads that are delivered to site from external 3rd parties to have weights clearly marked on them.
- Lift Supervisors to take a more active role on site for small generic lifting operations.
- Review of Point of Work Task/Briefings to make sure they cover the specific risks of small lifts.

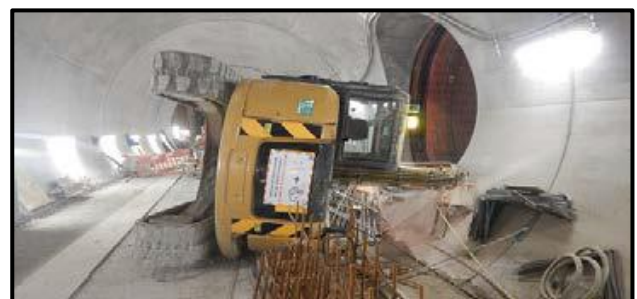
Overtuned excavator when being used as lifting equipment
