## ALERT

### Pressure Wash Accident

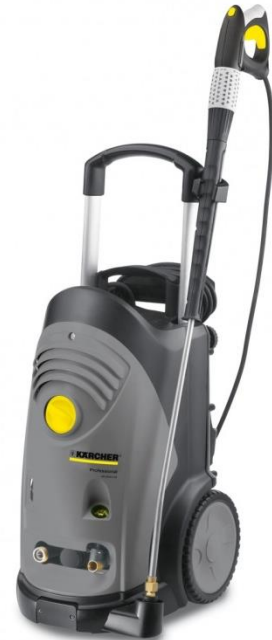
Model: Kärcher Professional HD 9/20-4M

On Saturday 10<sup>th</sup> September at C510 Whitechapel, an accident occurred when an operative was removing a ¾” bagging from the inlet of a Kärcher Professional HD 9/20-4M pressure washer. The IP turned off the water feed and released the pressure at the lance as normal. As the IP went to disconnect the water feed from the pressure washer, boiling water sprayed back from inside the pressure washer causing scalds to their hands. The IP was treated by the first aider on site and then taken to A&E.

As a precautionary measure, C510 suspended further use of the model HD 9/20-4M until the conclusion of their investigation has been reached. In the interim alternative equipment has been sourced.

- This hazard is specific to the Kärcher Professional HD 9/20-4M.
- The Operating Manual for the HD 9/20 does explain that there is:  
*‘Danger of scalding by means of hot water. The water remaining in the switched off device can get heated up. When you remove the hose from the water inlet, the heated water can spray out and cause scalding. Remove the hose only when the device has cooled down’*  
The manufacturer has been contacted to clarify this text, in particular about the cooling down period.
- In the meantime be aware of the possibility of this hazard and please ensure the pressure washer has cooled down before removing the water feed.
- Further to this, discussions are to be had with the manufacturer to gain more understanding of the equipment and considerations. An additional update will be issued if required.
