Safety Alert

Number: 16-17

Subject: Man Fell into Manhole On-Board Supply Vessel

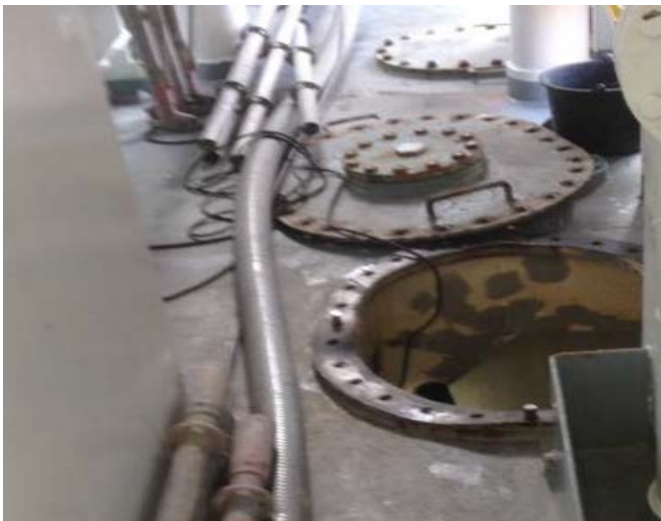
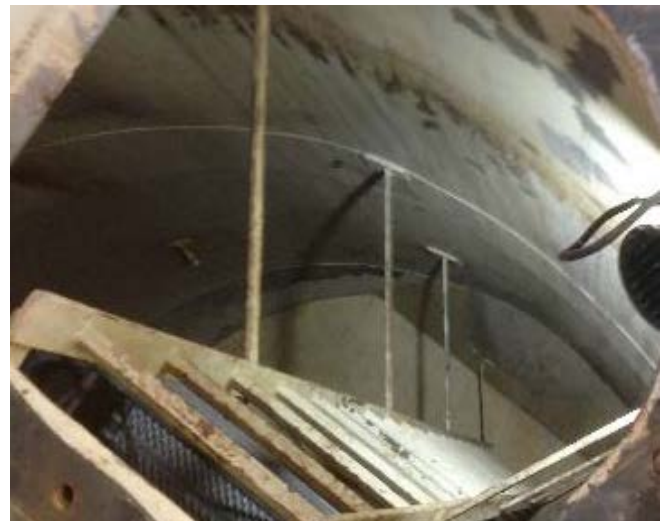
Photographs / Supporting Information

During vessel loading, the shore-side foreman walked into the "Safe Haven" area of the vessel and stepped into an open manhole. The Foreman managed to catch himself and prevent a free-fall of 5 meters into the tank. Foreman suffered a laceration on his shin requiring 3 stitches and has some bruising on his forearm.

- Lack of barriers, open manholes
- Several different activities on-going at same time
- Lack of coordination of activities

- Covering of manholes with gratings during work
- Ensure on-going work is coordinated between the work parties in the same area, through toolbox talk
