## **Health and Safety Alert**

Infrastructure Allianc	e repair clamp incident
------------------------	-------------------------

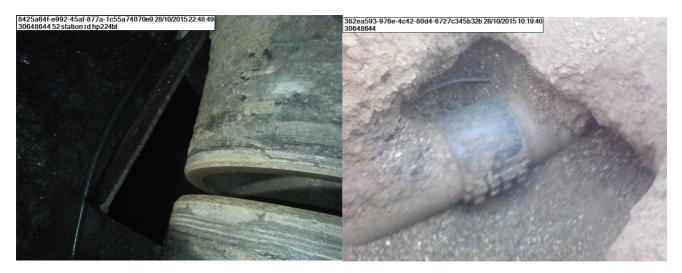
We are currently investigating an incident in which a colleague in the Infrastructure Alliance suffered a fractured eye socket and broken fingers whilst undertaking the installation of a repair clamp on a burst water main. It is believed that the clamp gave way from the main with the IP still in the excavation, flooding the area and forcing debris into his face and hand.

A full investigation is currently underway, and learning points will be shared in due course. In the meantime, please ensure that:

- Operatives do not re-enter excavations during re-charge.
- The appropriate manufacturer's instructions are available, understood and followed when using repair clamps.
- Operatives are trained and competent to undertake clamp repairs.
- The condition of work equipment is regularly inspected and fit for purpose.
- A suitable risk assessment and safe system of work is available and understood to all those that might be at risk.
