# **Safety Alert**

## Number: 16-25 Subject: Injury to Crew Member

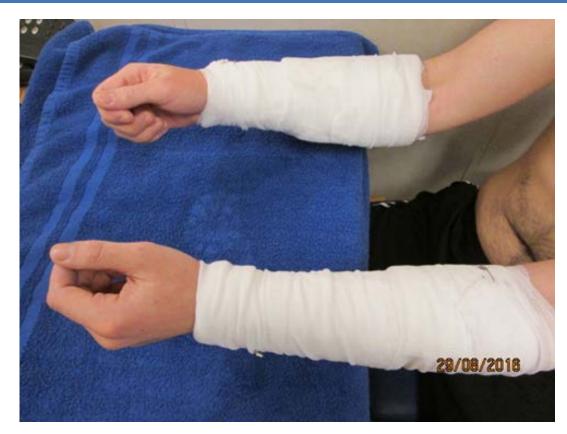
#### **Photographs / Supporting Information**

At approximately 13.19 the IP removed the cap from the HT header tank on main engine no. 3, as the engine was running the removal of the cap released 90°C water at 7 psi, spraying it across both forearms of the IP.

The contact with high temperature water resulted in 2nd degree burns to both arms of the IP. First aid treatment was given on-board.

- All new joining crew, whether recently qualified or new to the vessel, should be given a thorough familiarisation of all aspects of their duties on board.
- Assumptions should not be made that, because a newly qualified officer has passed his or her Certificate of Competency, they are instantly competent to undertake unsupervised watch keeping. An assessment should be made of the individual's competence prior to transfer of such responsibility.
- No maintenance to take place on machinery, either running or in standby mode, whilst in the 500m zone.
- Cadets have the same authority and responsibilities to stop the job as all other crew members. The purpose of cadetships is to learn and develop, if you are unsure, ask.
- Consider use of a warning sign (where not already present) to not release the filler cap when the engine is running and / or the coolant is hot.
